NIST Special Publication 901

The January 17, 1995 Hyogoken-Nanbu (Kobe) Earthquake

*Performance of Structures, Lifelines, and Fire
Protection Systems*

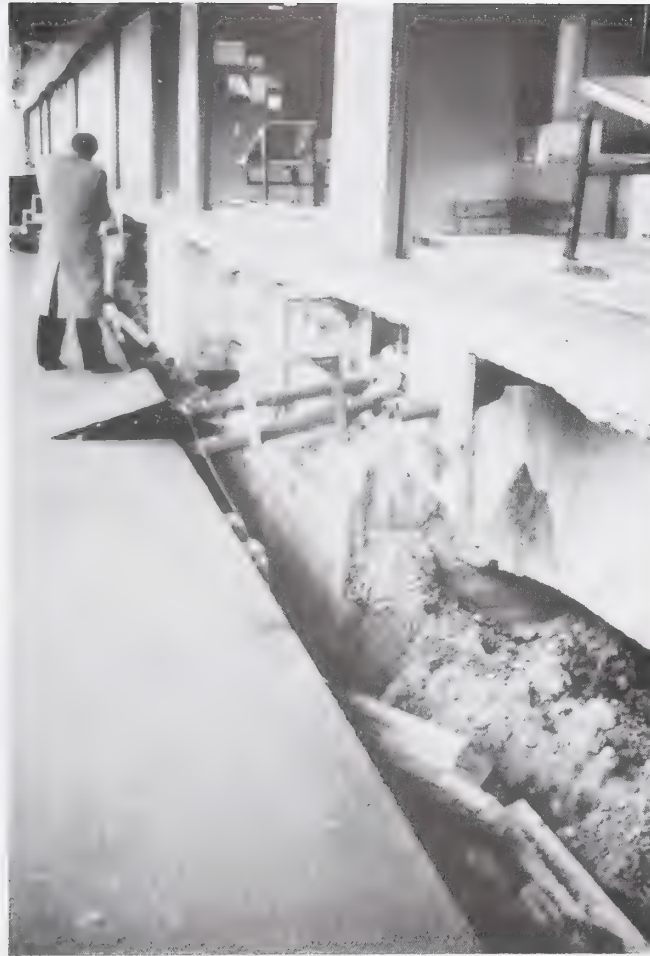
Photo 23 Differential settlement of approximately one meter along the front of pile supported ferry terminal on Port Island connecting Kobe to Kansai Airport. Utility connections were left hanging.

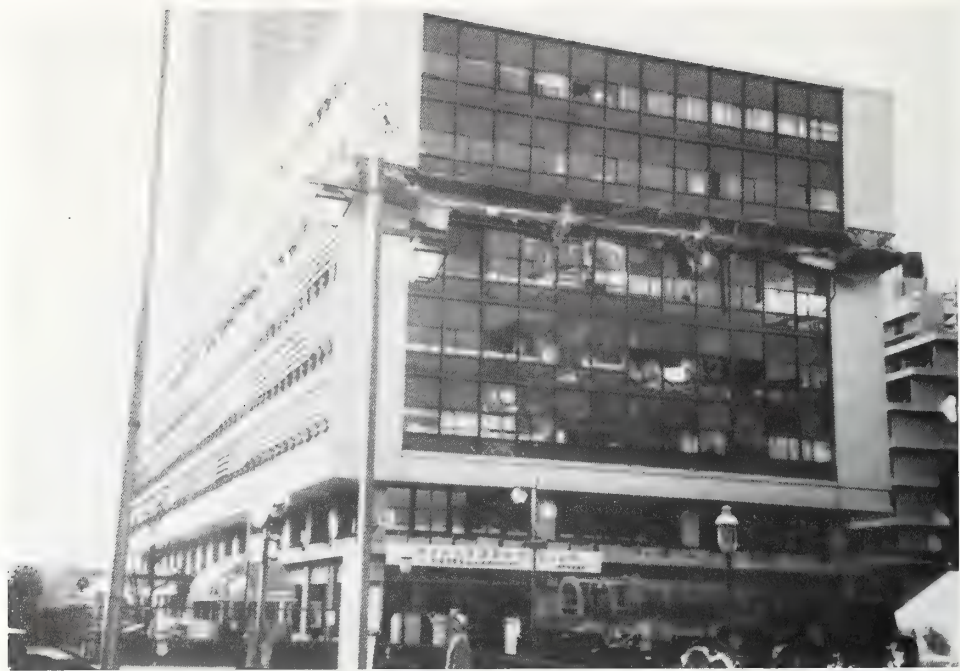
Photo 24 Pancaked sixth floor of City Hall Annex.

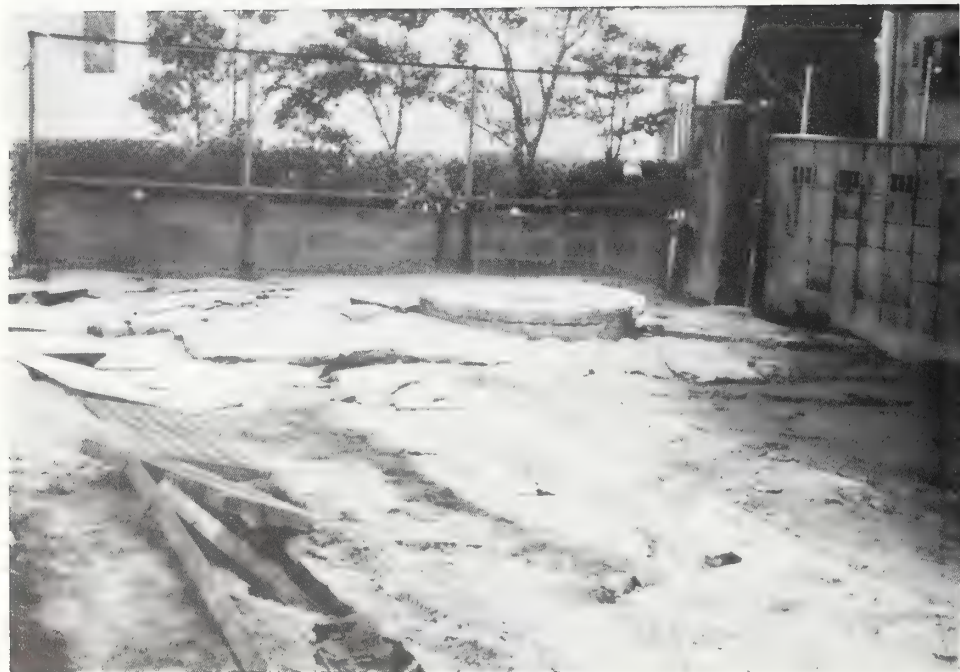
Photo 25 Manhole floated as a result of liquefaction near the wastewater treatment plant.

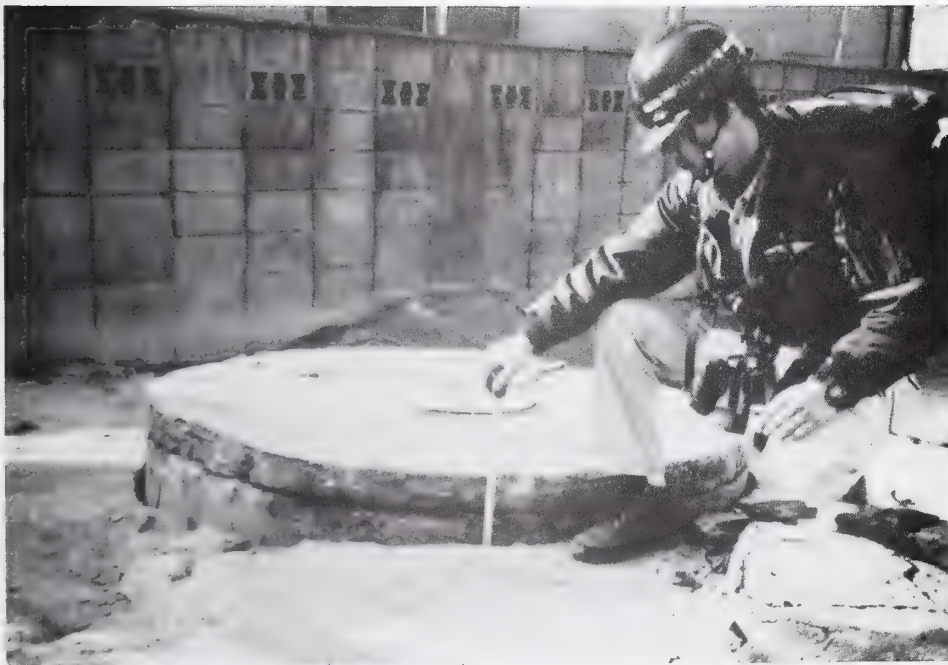
Photo 26 Same as Photo 25.

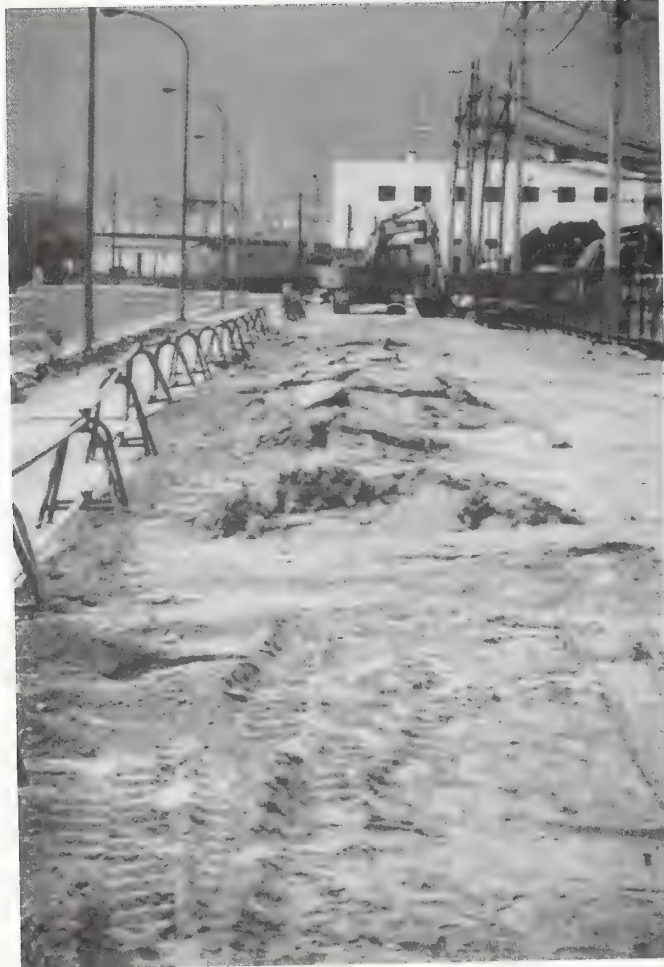
Photo 27 A 500 mm diameter sewer floated upward on Port Island, resulting in the upheaval of ground.

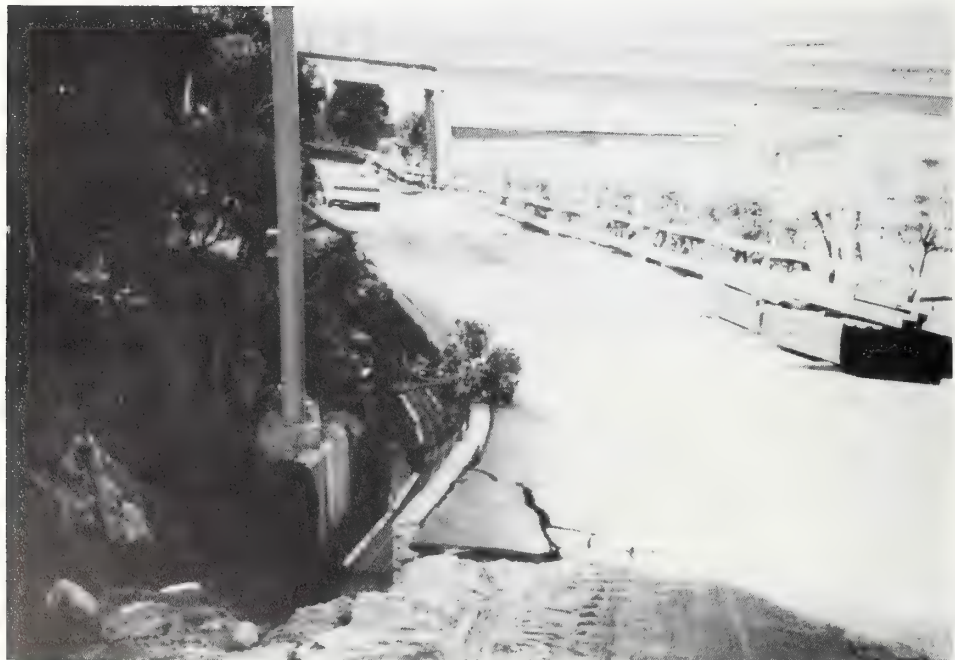
Lateral deformation caused severe damage to underground structures and facilities founded on spread footings. The effluent channel separated in 4 places (Photo 31). The pipe rack distorted from foundation settlement (Photo 32).

Photo 31 Effluent channel, approximately 2 m², offset nearly one meter from lateral spreading.

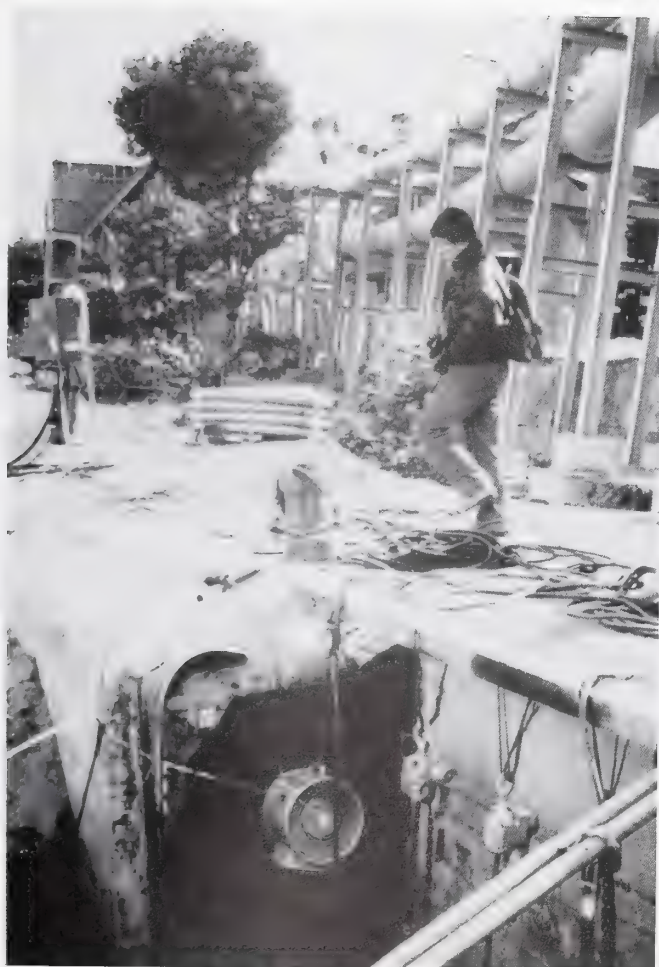
Photo 32 Pipe rack foundations adjacent to channel settled approximately one meter, distorting piping.

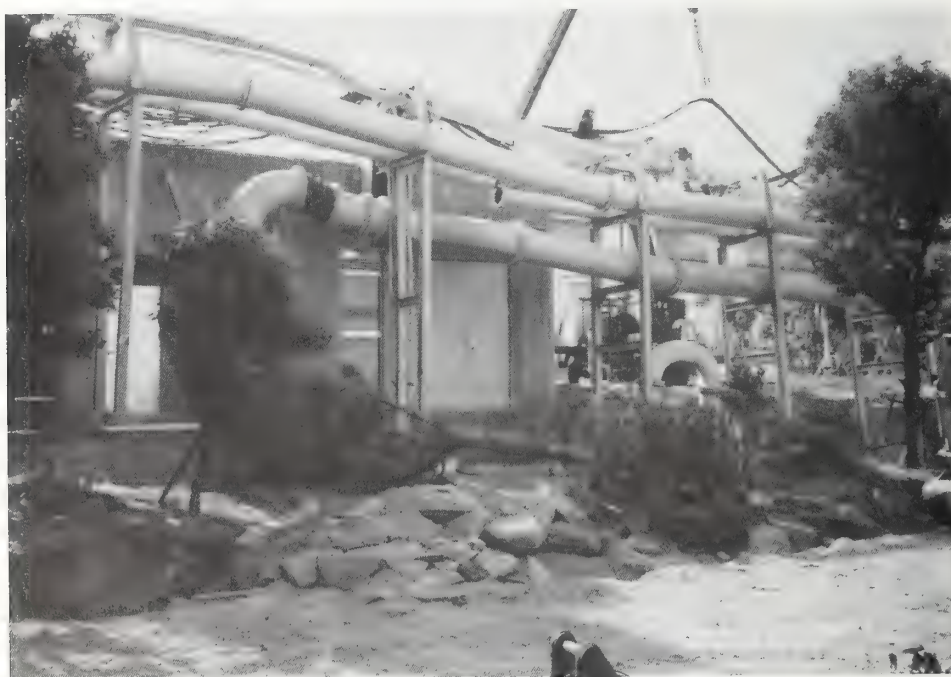
Differential settlement and lateral spreading of approximately 600 mm occurred at the filter building, as shown in Photos 38 and 39 resulting in some pile damage. The control building and the sludge thickener room moved north 60 cm (Photos 40, 41). The

Photo 39 Piping distorted as a result of the building movement.

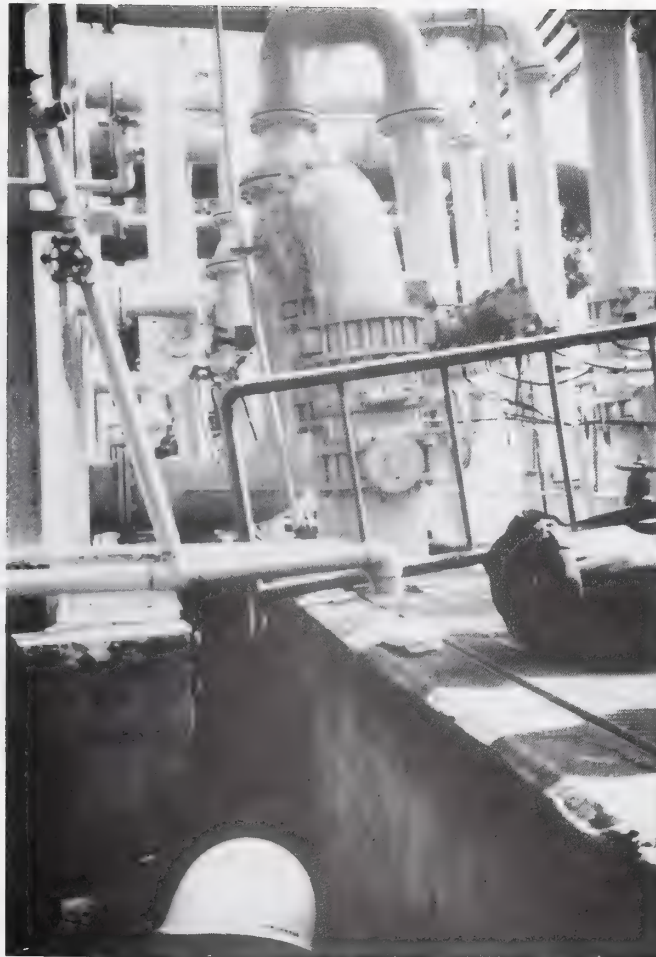
Photo 40

Control building (upper right), which is pile supported, moved towards inlet approximately 30 cm, moving away from adjacent building which had a basement.

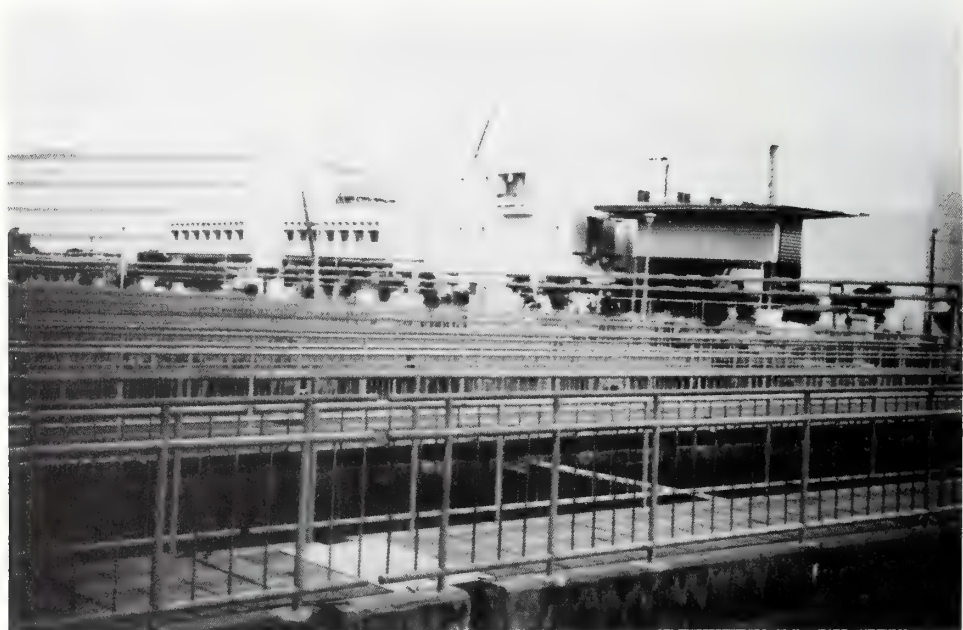
Photo 41 Shows the gap between the two buildings in Photo 40.

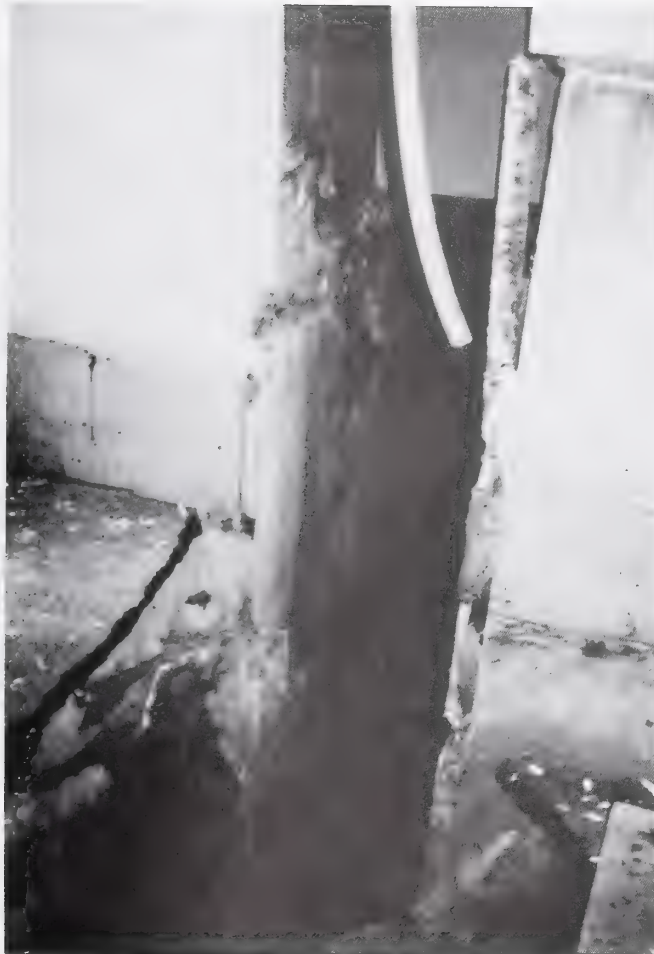
Photo 42 Piping distorted as a result of the movement.

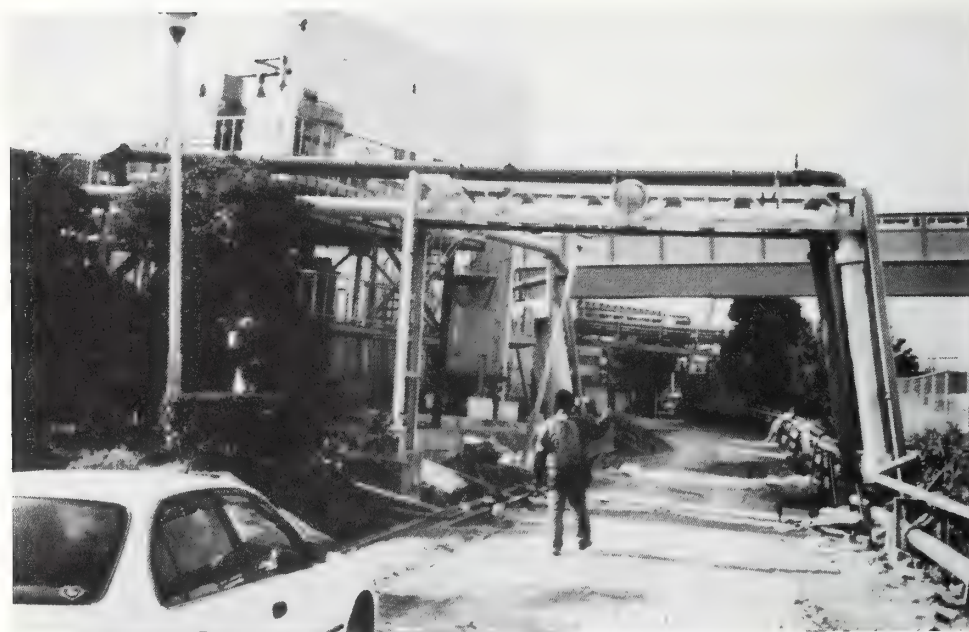
Photo 43 Piping and equipment distorted as a result of subsidence of the structures' foundation.

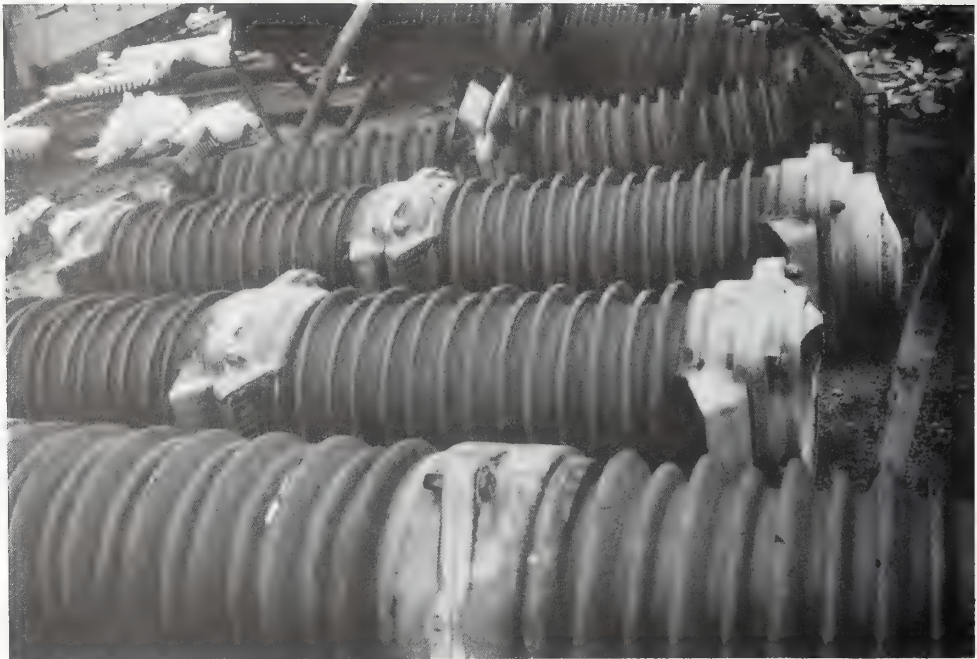
Figure 5.4.30 The standoff incorporated into the design of the base of the lightning arrester failed.

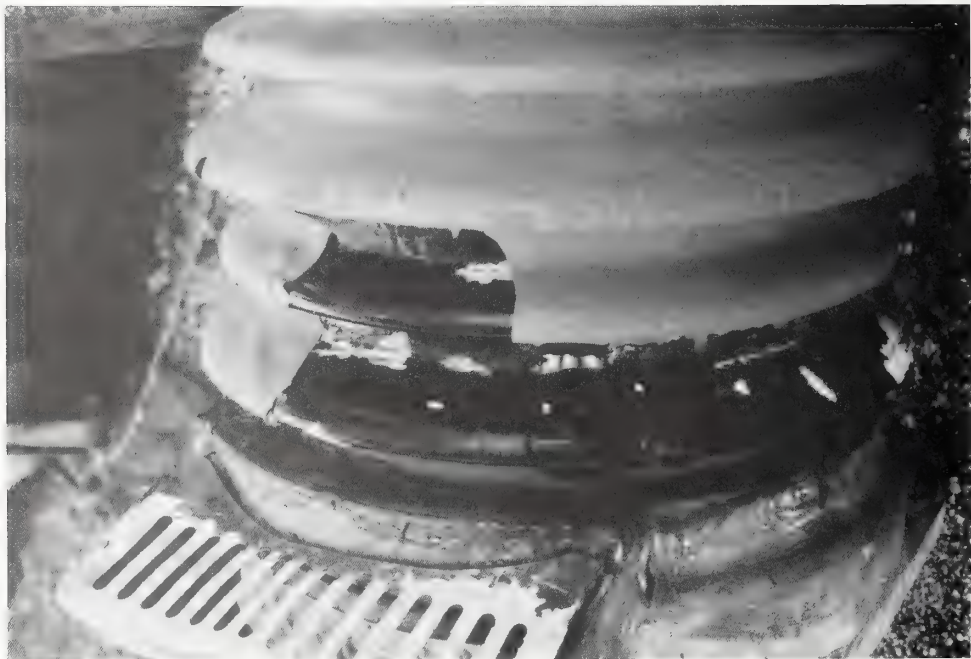
Figure 5.4.31 Damaged 275 kV lightning arrester in the grave yard.

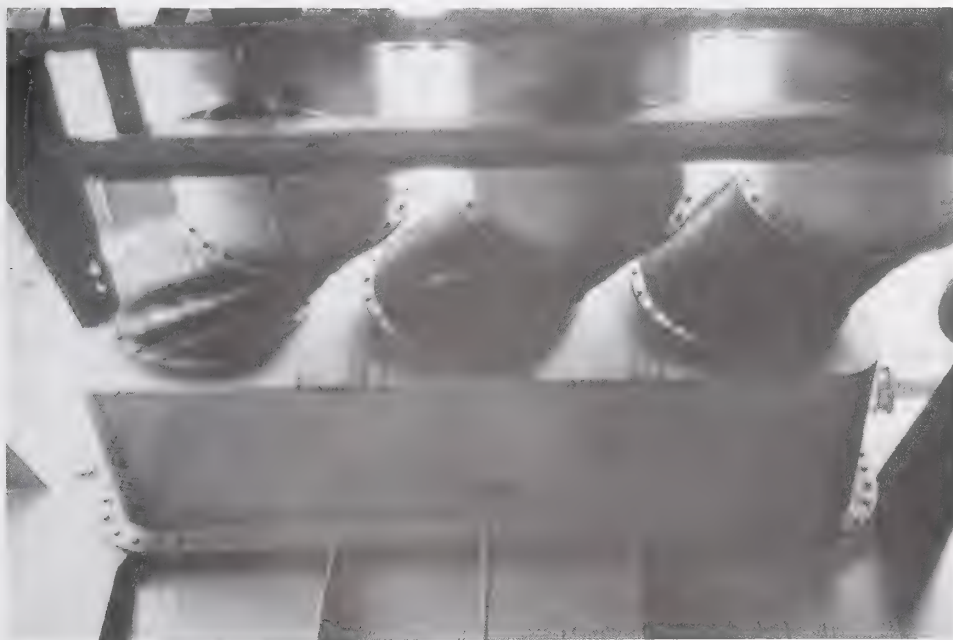
- (b) Several bolted transformers moved even though they appeared to have substantial anchorage. While new transformers are typically welded to embedments in the United States, bolts are often used for retrofits. What were the design and actual loads on the equipment that failed and what was the cause of the anchorage failures?

Figure 5.4.33 Bolts anchoring a transformer failed allowing the unit to slide 45 cm and causing damage to bushings.

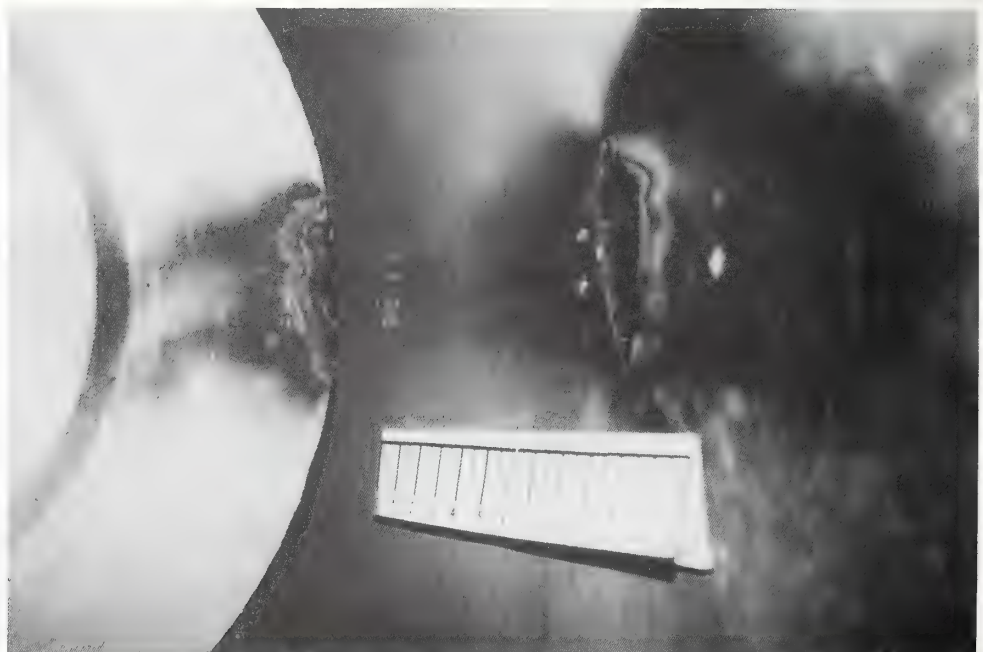
Figure 5.4.35 Transformer control cables were almost sheared off due to movement of the transformer.

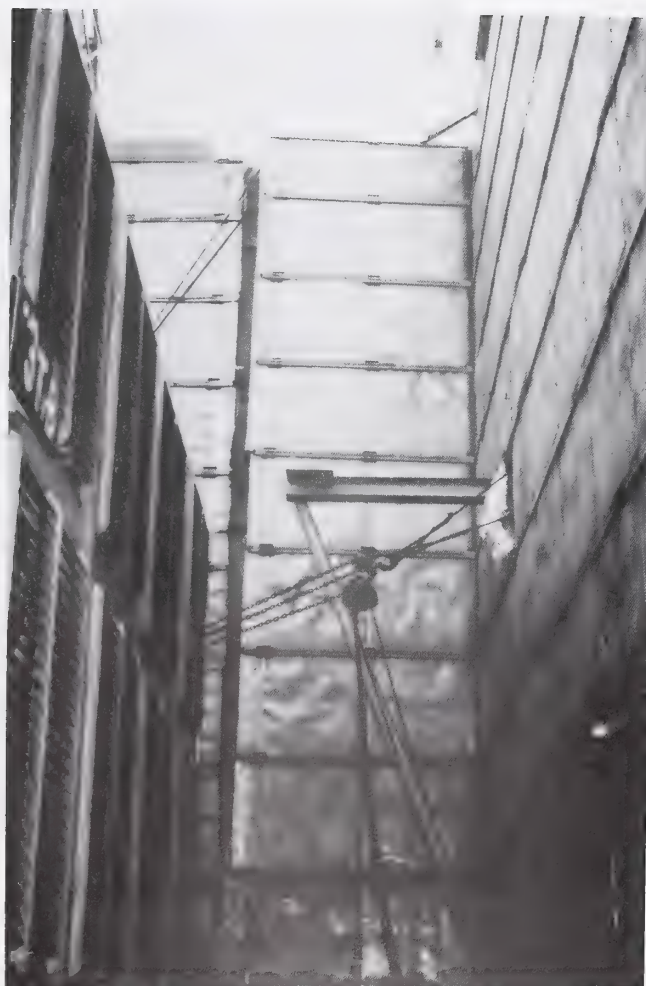
Figure 5.4.36 Movement of transformer damaged cabinet and shorted transformer case the tertiary output.

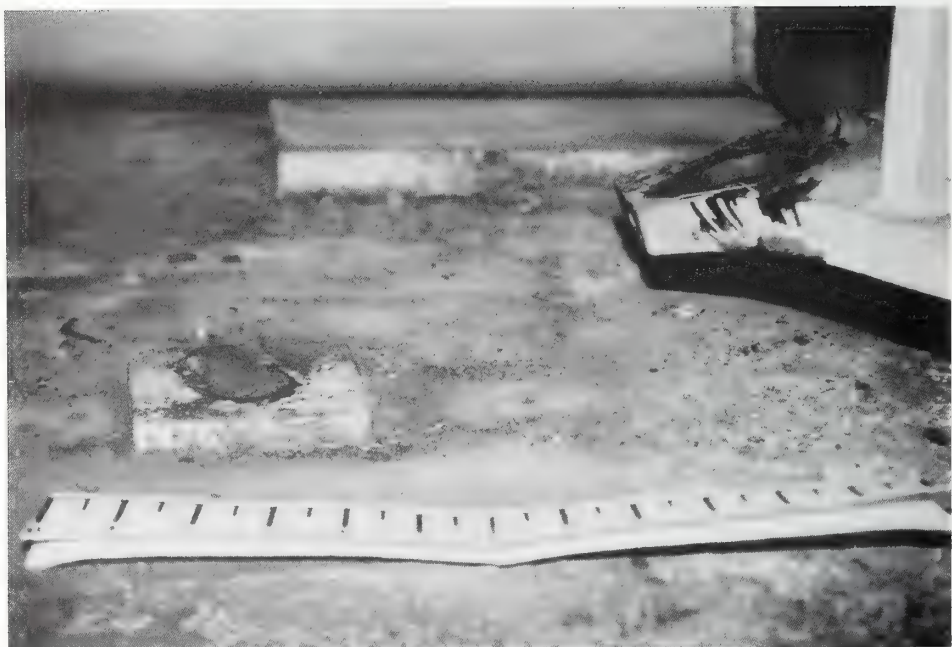
Figure 5.4.37

Transformer acoustical enclosure support was damaged and the enclosure shifted.

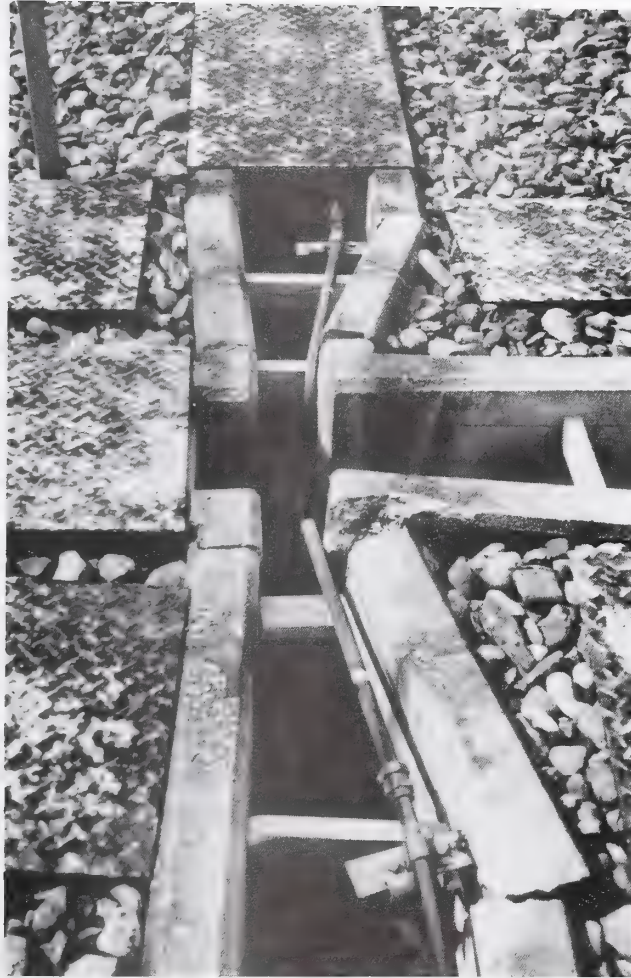
Figure 5.4.43

A long crack in the ground surface opened about 25 cm and damaged cable trenches.

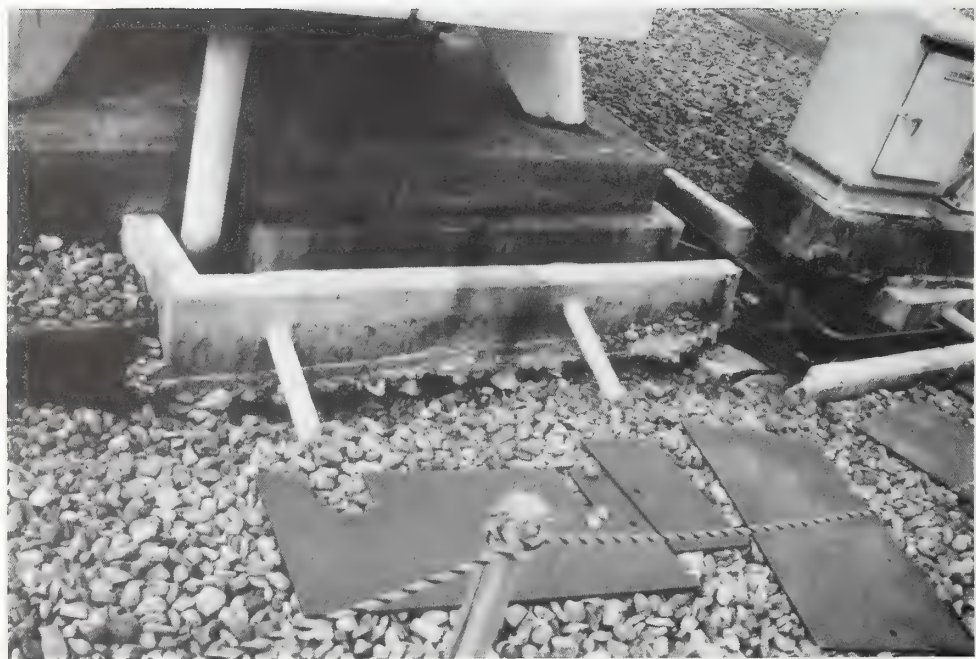
Figure 5.4.44

Cable trenches were deformed with the ground fracturing an air line
be leaving control cables undamaged.

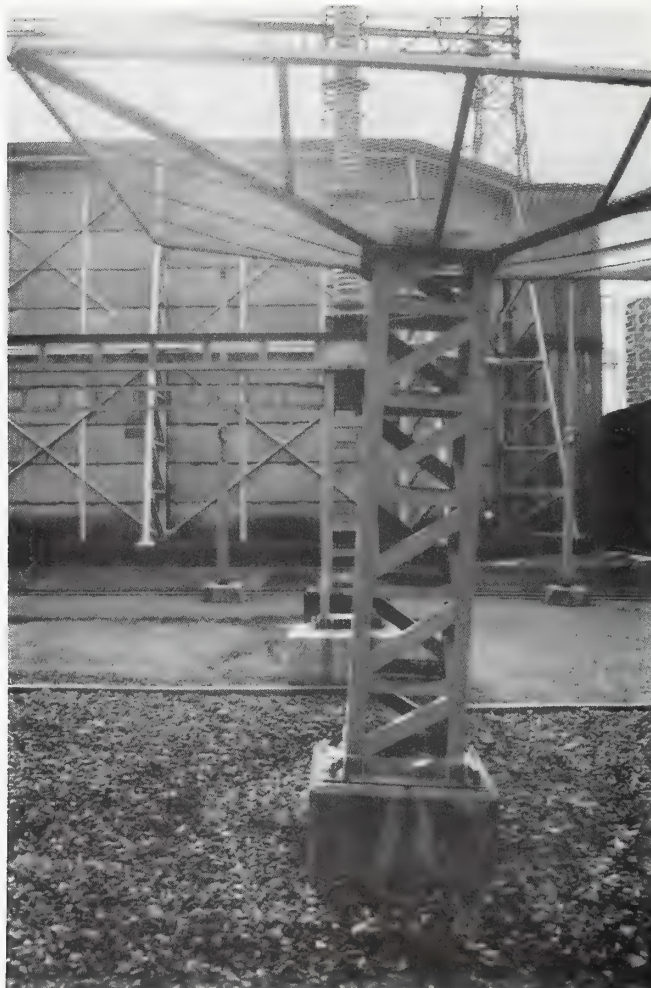
Figure 5.4.47

A lightning arrester support structure tipped about 2-1/2 degrees and probably contributed to the failure of the lightning arrester.

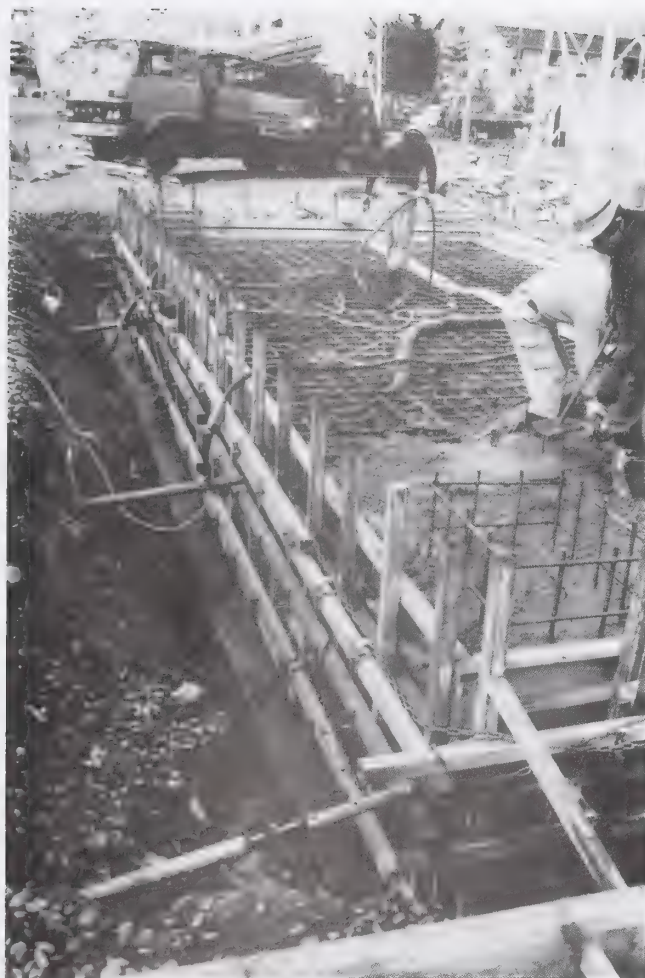
Figure 5.4.48

A new monolithic disconnect switch pad replaced individual footings that were disturbed by a surface crack in the soil.

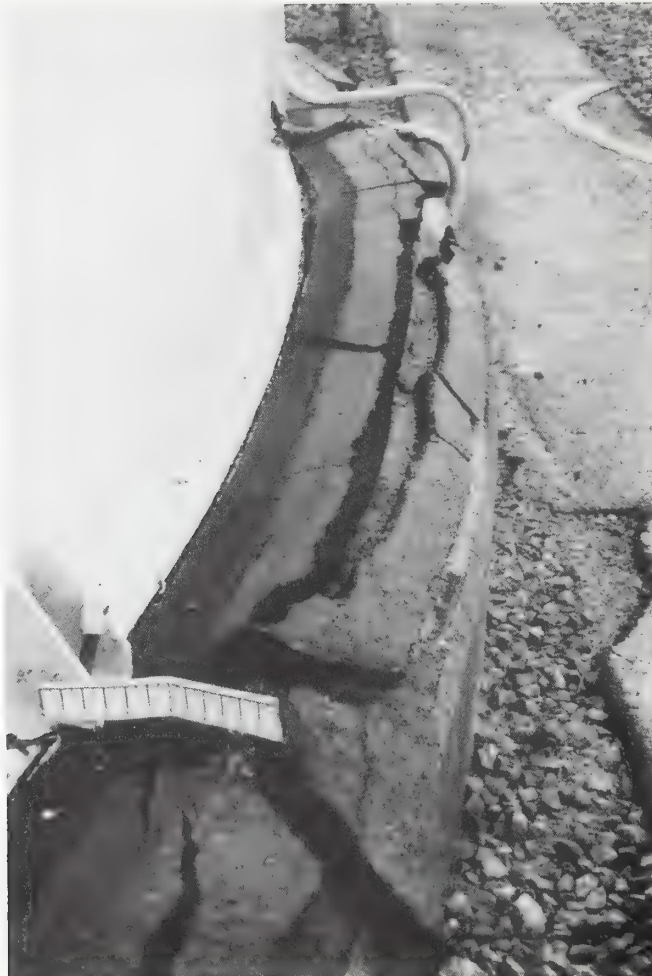
Figure 5.4.49

The asphalt surface between the tank and the concrete ring was broken and the bolts stretched or were pulled out due to rocking of the tank.

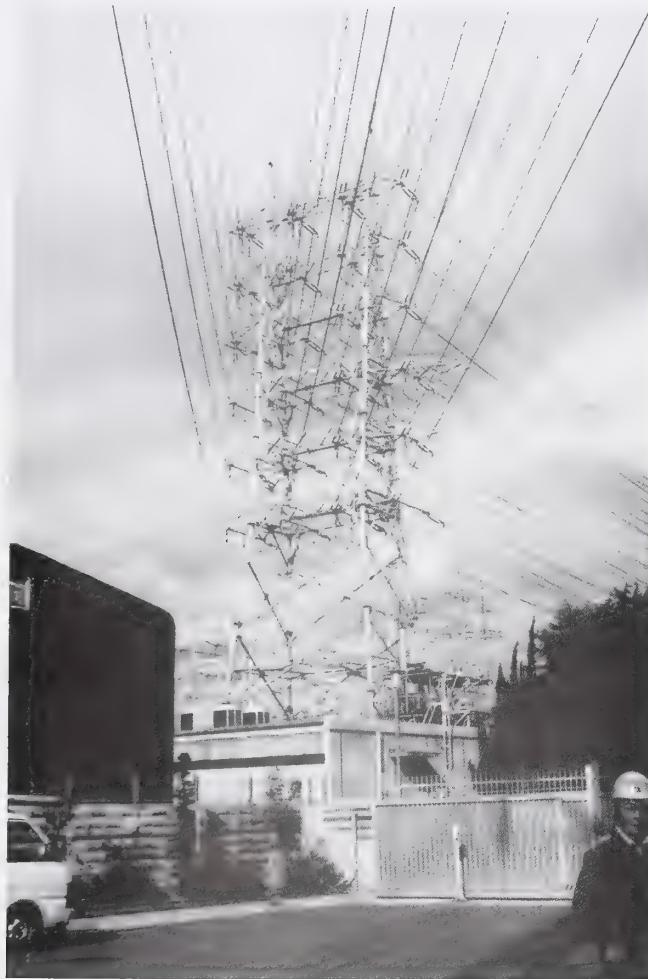
Figure 5.4.53

Post insulators that restrain the lines as they pass under the support arm failed on several towers, but did not cause disruption.

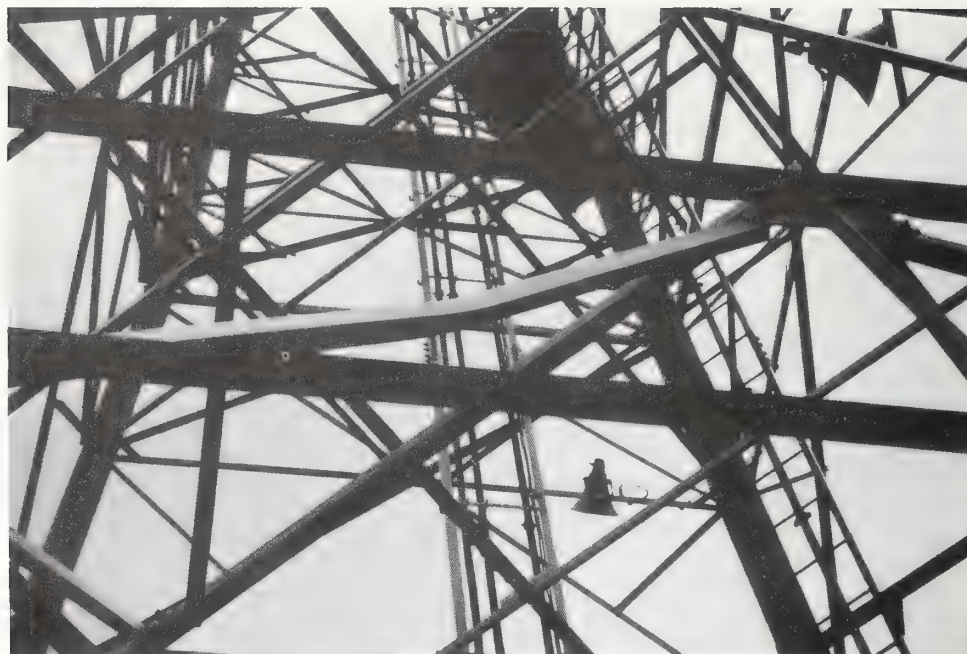
Figure 5.4.54

The bent member in a microwave tower is very unusual, but it did not effect operations.

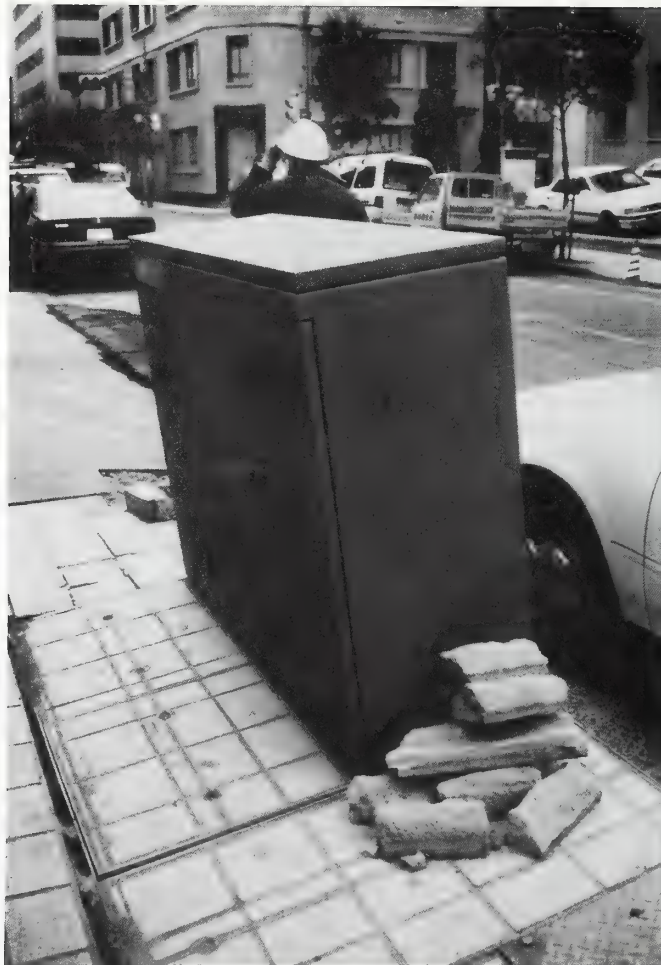
Figure 5.4.72

The conduit and the foundation pad under this transformer pad was disrupted in down town Kobe due to soil liquefaction.

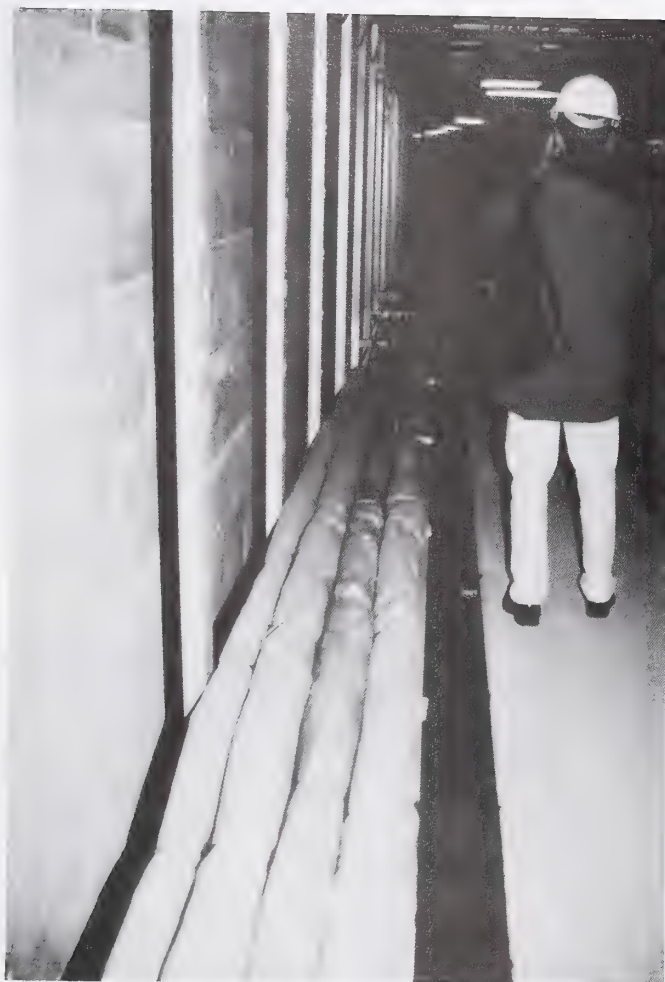
Figure 5.5.4

Trunk lines in the joint utility tunnel had fire retardant covers near entrances and stairways.

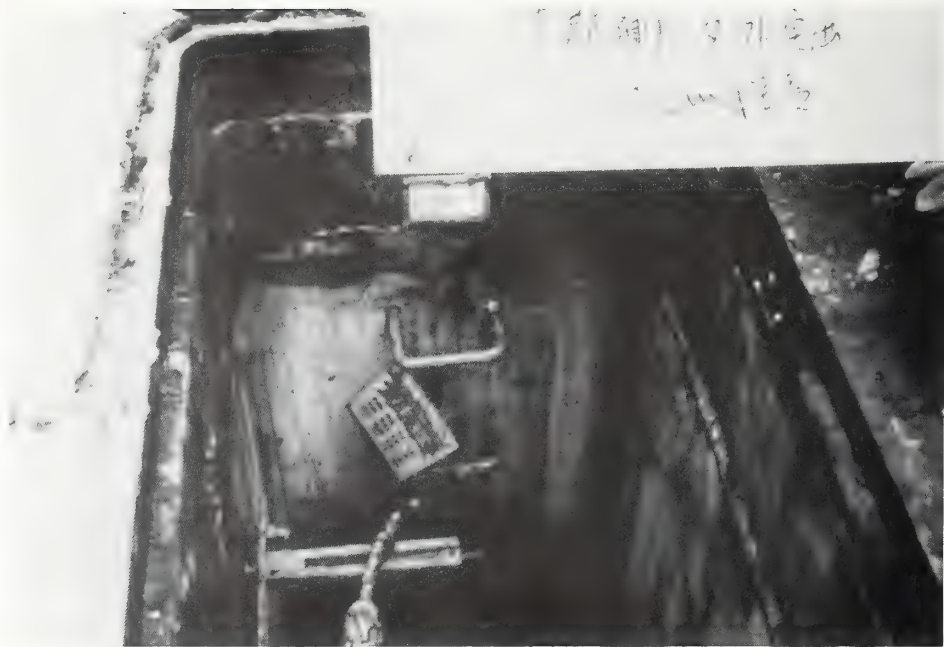
Figure 5.5.5

At many manholes, the conduits were pushed into the manhole boxes by up to 30 cm. This can exceed the available cable slack and cause a cable failure (Figure 5.5.5). The relative motion also can damage the manhole-conduit seal, and water seepage can also damage the cables. In older conduits, cable slack was 2 cm at the manholes, and some of these broke. At new conduits, cable slack was up to 15 cm, and these did not break. It appears that there can be large variations in slack provided to cables at manholes. In an earlier visit to Tsukuba City, an NTT Outside Plant research group proposed service loops of about 8 cm diameter before each splice joint. However, a tie-wrap to secure the loop to a tray or shelf was also recommended, so that the deployment of the slack may be impeded. Liquefaction and soil movement also moved junction boxes (Figure 5.5.6). Figure 5.5.7 shows a schematic diagram of a 4 cm offset of plates used to form the manhole entry. Subsidence of soil around manholes also caused conduit failures (Figure 5.5.8). Conduit carried on bridges were also damaged due to motion of the bridge deck (Figure 5.5.9). Subsidence in roadways caused extensive damage (Figures 5.5.10 and 5.5.11). Telephone booths were also severely damaged by soil

Cables were pushed into manhole boxed breaking water seals and in some cases damaging cables.

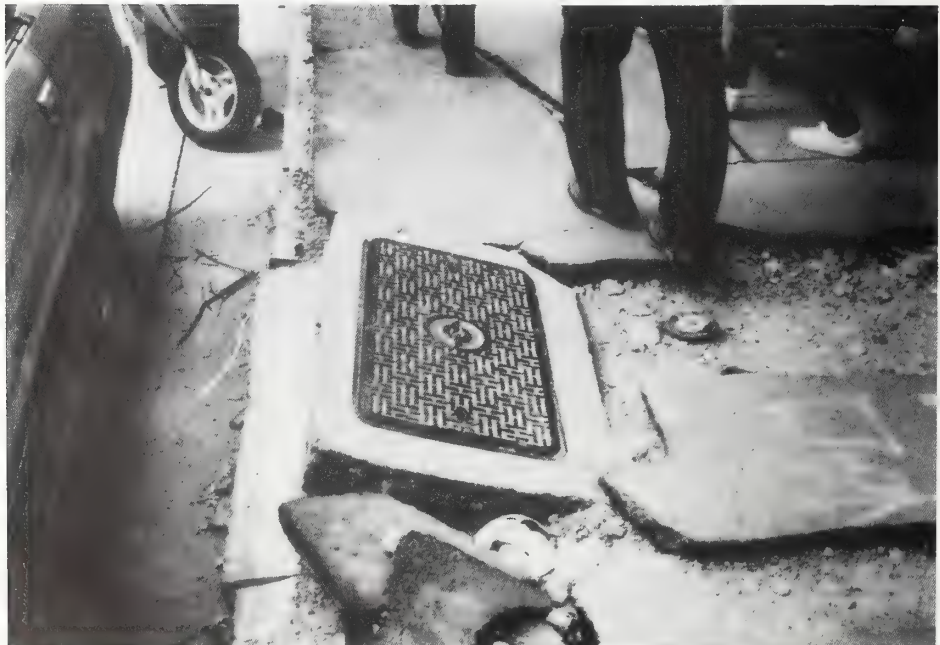
Figure 5.5.6

Movement of manhole box can damage conduits and trunk lines.

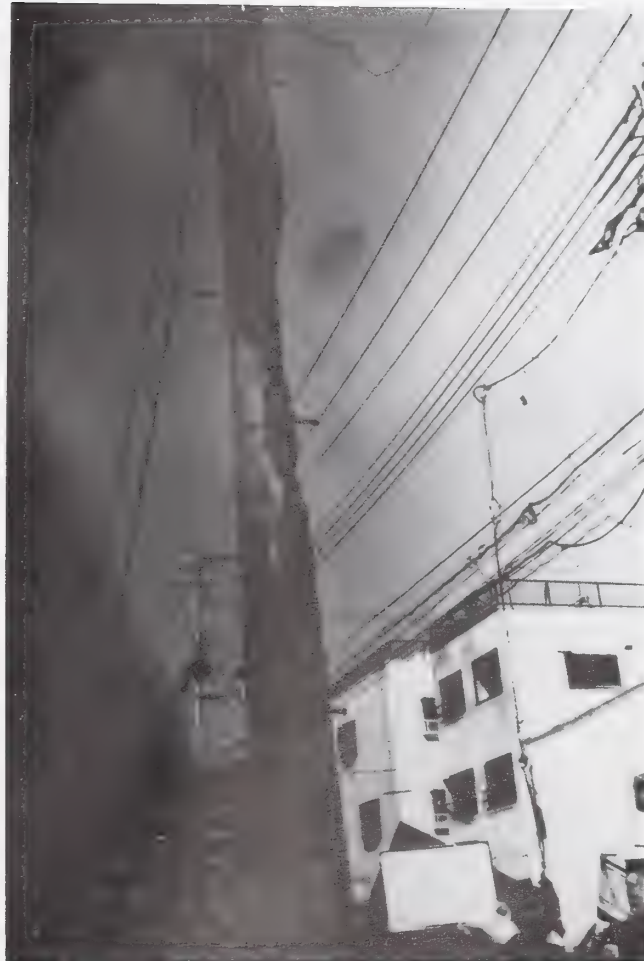
Figure 5.5.14 Fire damaged aerial lines and cables along the pole.

The extensive damage to concrete poles used to carry aerial lines is discussed in Section 5.4.2. In addition to the failure of poles due to liquefaction, inertial loads, interaction with fallen houses and other poles, some lines were damaged due to fire (Figure 5.5.14).

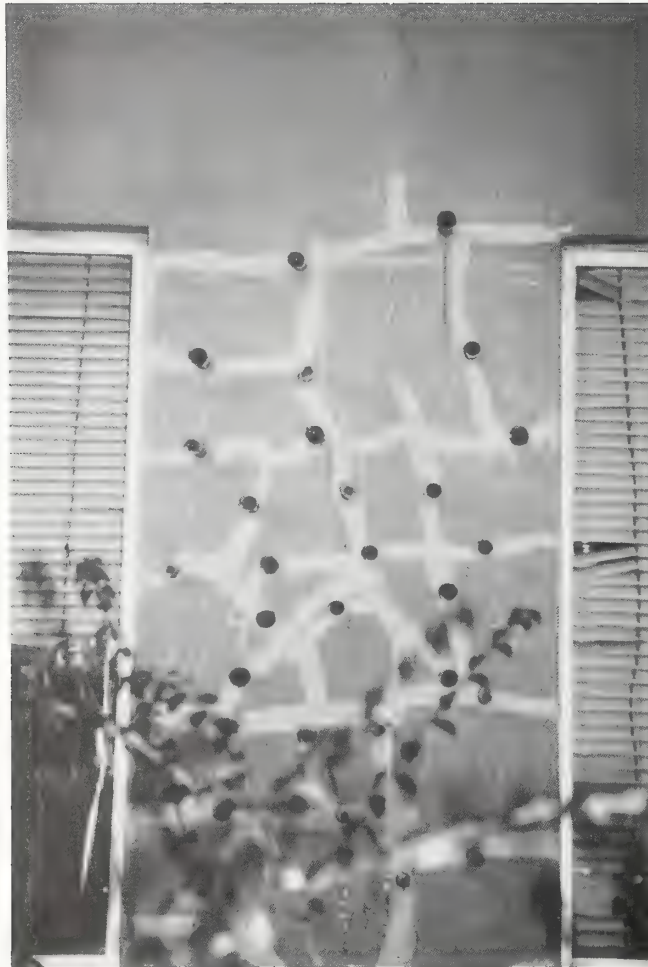
Figure 5.6.1

Column on the first floor of the old hospital being repaired with epoxy injection.

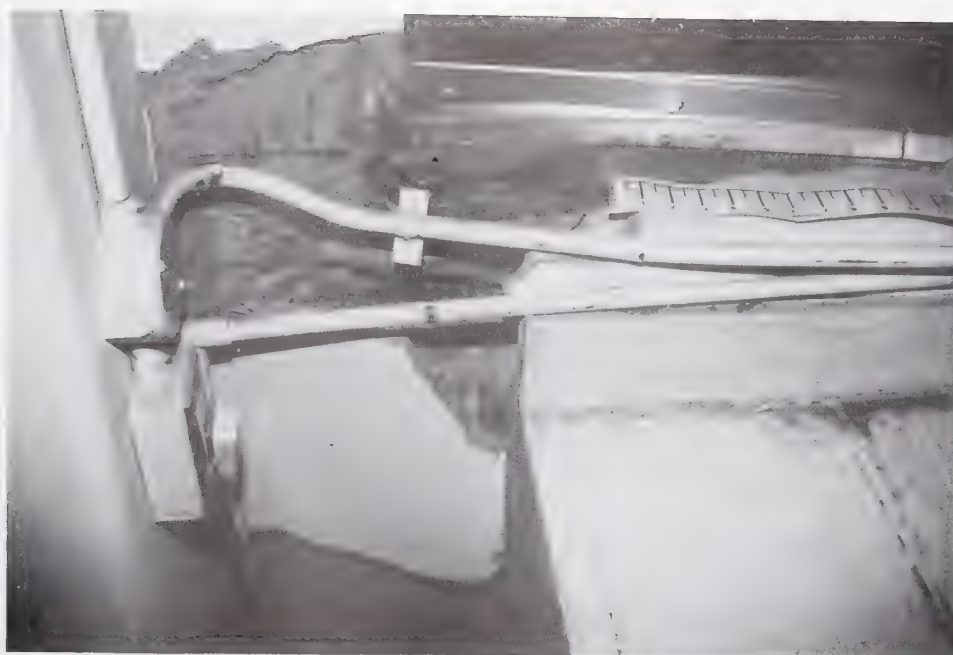
Figure 5.6.2

Beam shattered due to interaction between the two wings of the hospital at cross walks connecting the buildings.

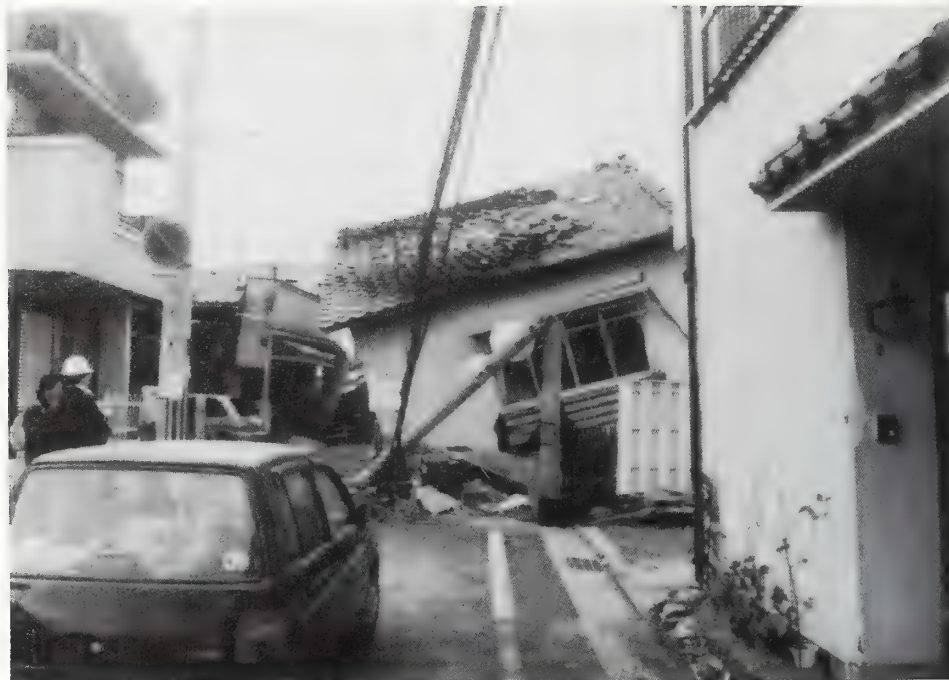
knocked down by the earthquake or torn from collapsed buildings creating potential arcing situations. Some electric lines were still connected to partially collapsed buildings (Figure 6.2.7). These lines may have stretched, creating a reduced cross sectional area of the wire, which could cause

ignition of a fire due to overheating. Insulation may have pulled away from the wires making short circuits or ground faults more likely. The majority of the fire damage occurred in areas of predominantly wooden construction which provided fuels to sustain and spread fires which ignited.

Figure 6.2.7 Example of electric power lines connected to a damaged house.
